## **Demonstration of Thermoplastic Composite I-Beam Design Bridge at Camp Mackall, NC**

Final Report on Projects FY08-16 and FY09-31

Under Installation Technology Transition Program (ITTP) Project FY08-16, "Innovative Recycled-Plastic I-Beam Bridge for Vehicular Traffic" and Project FY09-31, "Phase II, Load Testing and Tech Transfer for Design for Bridges on Military Installations for Military Vehicles."

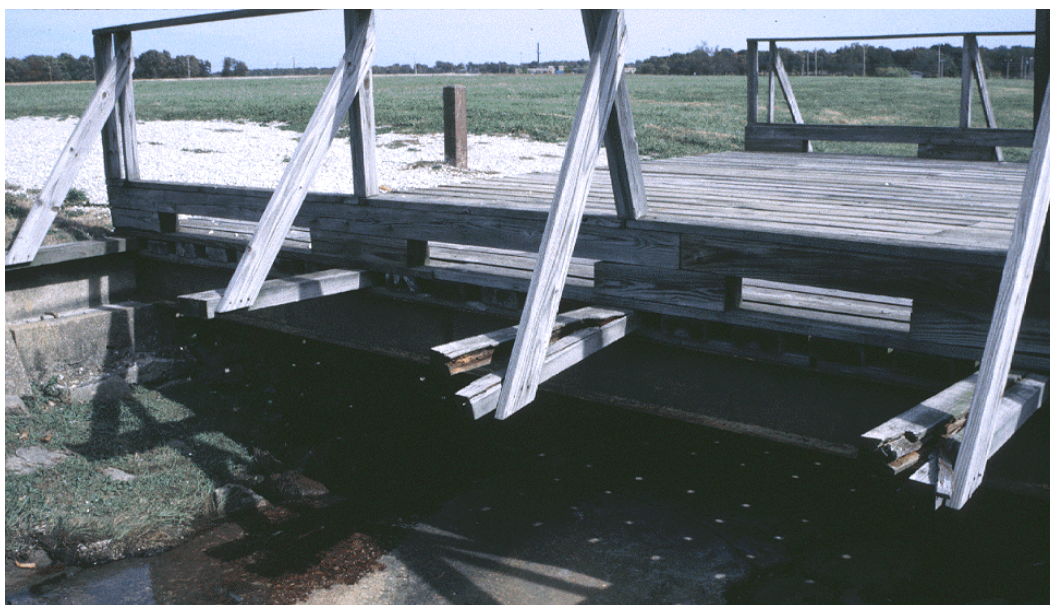
**Figure 2. Failing wood timbers on wood bridge structure at Fort Leonard Wood, MO.**

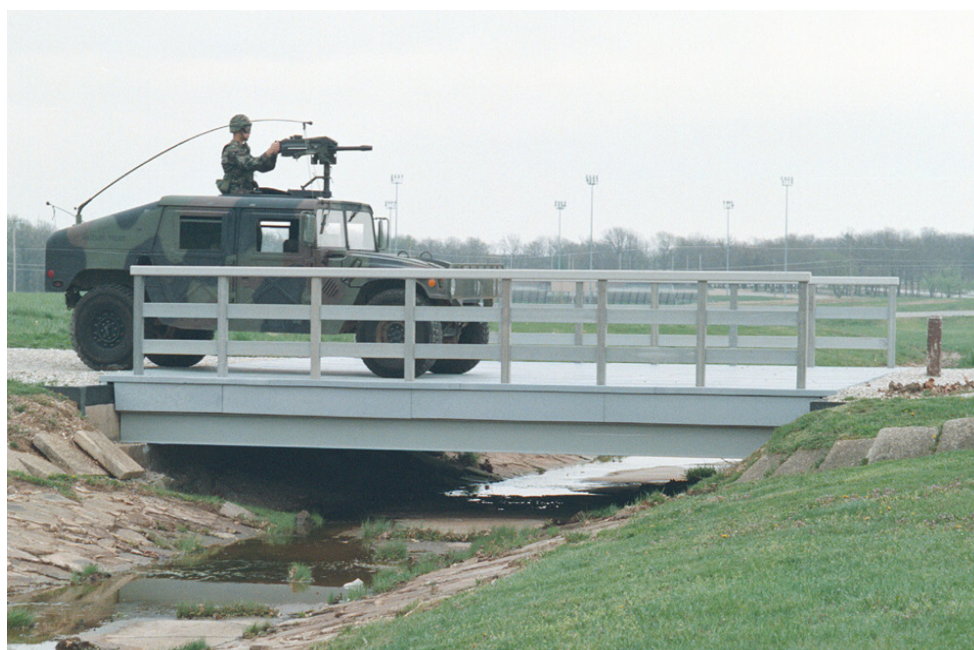
**Figure 3. Failing bridge replaced by the first-known plastic lumber vehicular bridge in the United States,<sup>5</sup> built during summer 1998 at Fort Leonard Wood, MO.**

Plastic lumber expands and contracts to a greater extent with changes in temperature than does wood or steel. Therefore, design features were incorporated to allow the plastic lumber bridge structure to move differentially relative to the steel members and the bridge abutments during such changes in temperature. These new design features included slotted connections between the plastic lumber joists and the steel girder to which they were attached to accommodate side-to-side movement, and a floating deck at the bridge abutments to accommodate end-to-end movement.

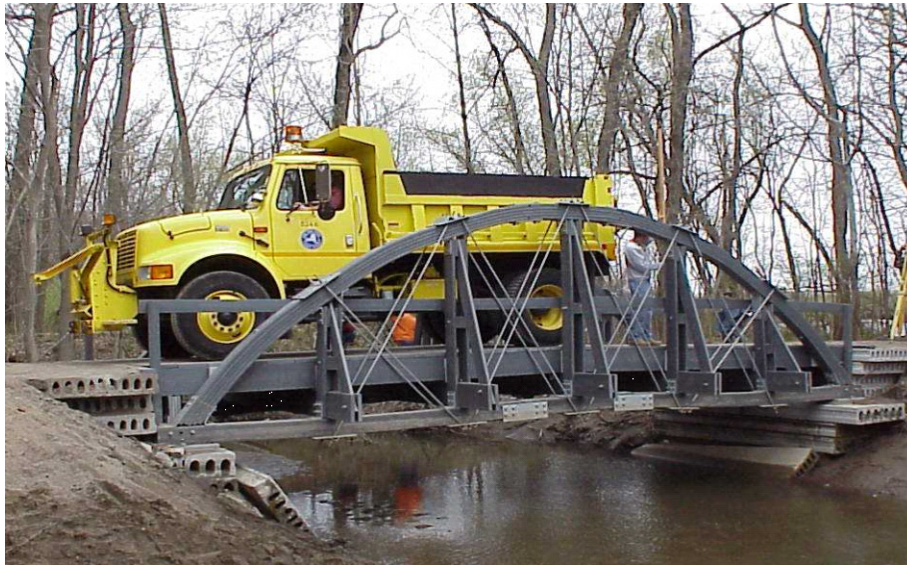
**Figure 4. Load testing the plastic lumber, arch-truss bridge in Albany, NY.**

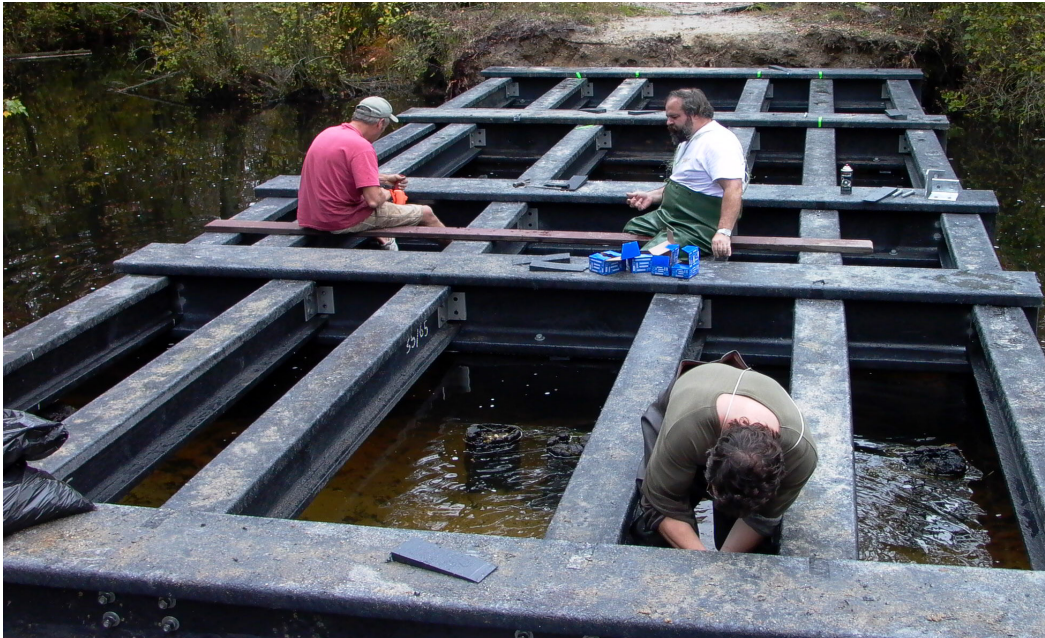
Figure 5. I-beam design bridge being constructed at Wharton State Forest, NJ.

In 2003, another all-plastic lumber bridge was built using I-beam plastic lumber structural members. This bridge, located in the Wharton State Forest, New Jersey, was designed for a Class H-20 rating (20 ton [18.1 Mg]) since it must be able to support a fire truck that might be needed to answer a call within this part of the forest. The I-beam design reduced the construction time and materials needed to build a bridge structure with the same load capacity compared to conventional joist and beam construction. Figure 5 shows this I-beam design bridge under construction.

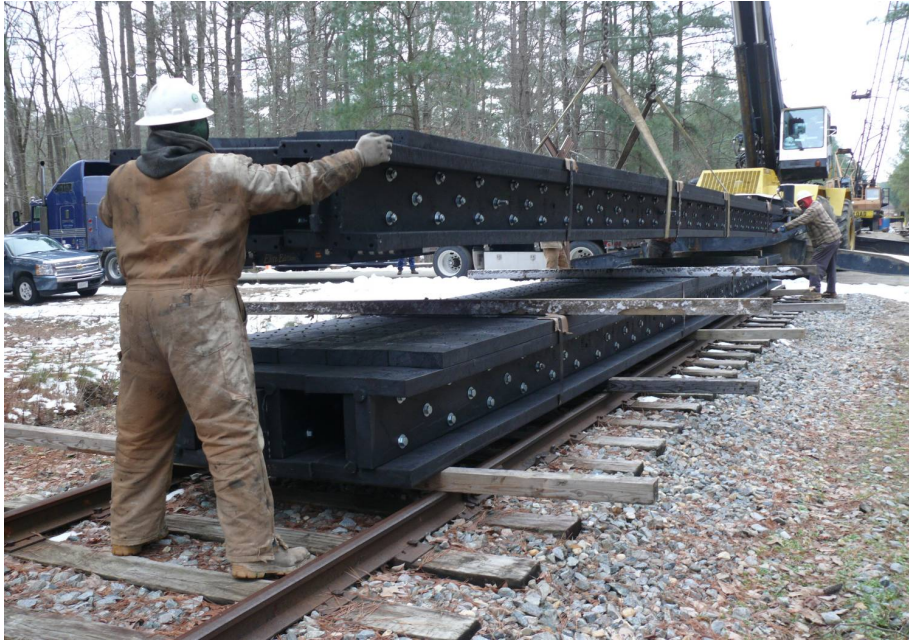
Figure 8. Factory-assembled deck section panels, prior to being installed.

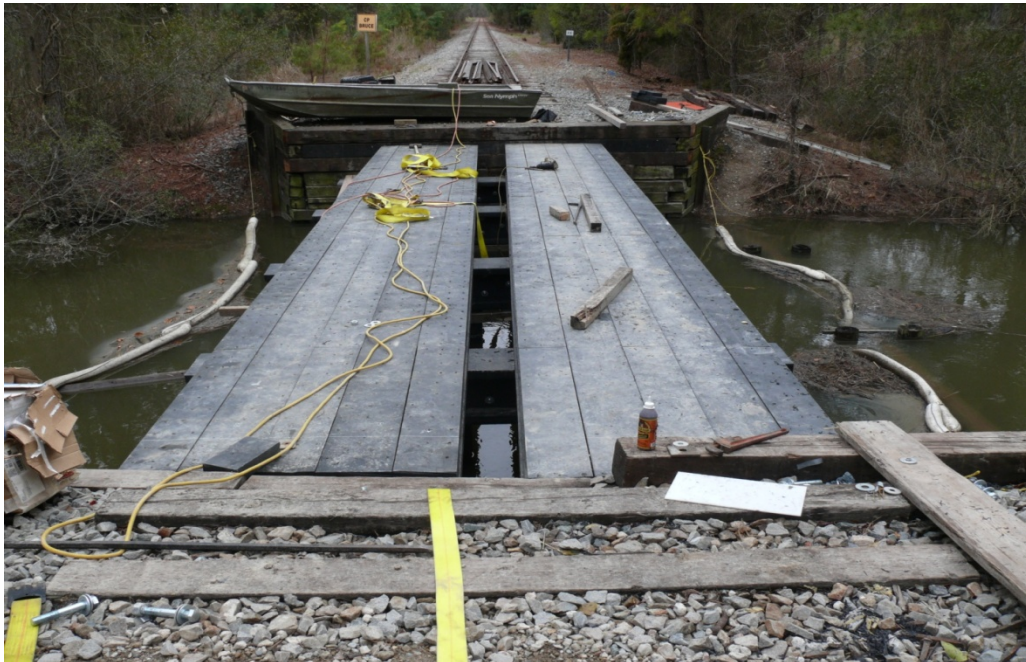
Figure 9. Factory-assembled panels being installed as the bridge deck.

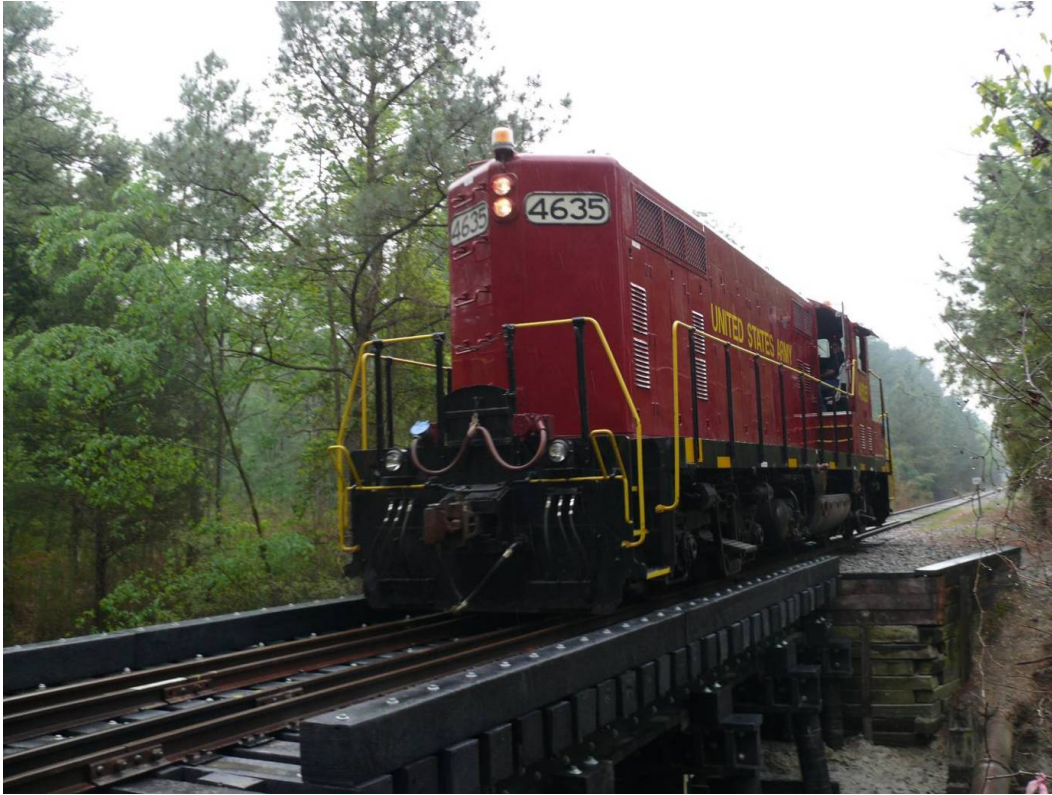
Figure 10. Locomotive used for load test at Fort Eustis on 21 April 2010.

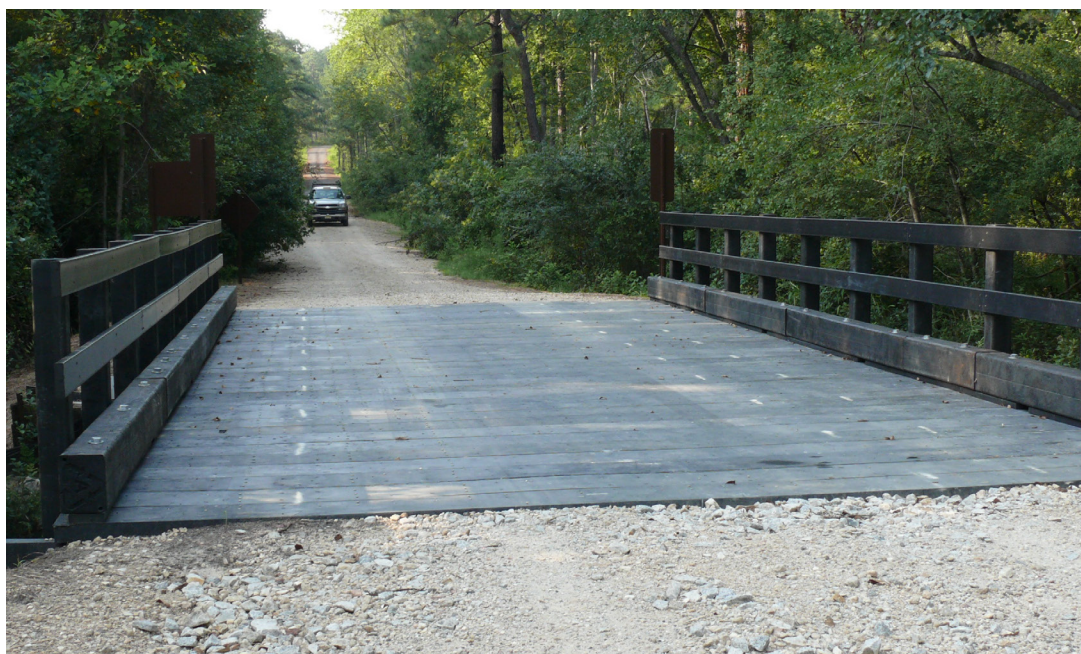
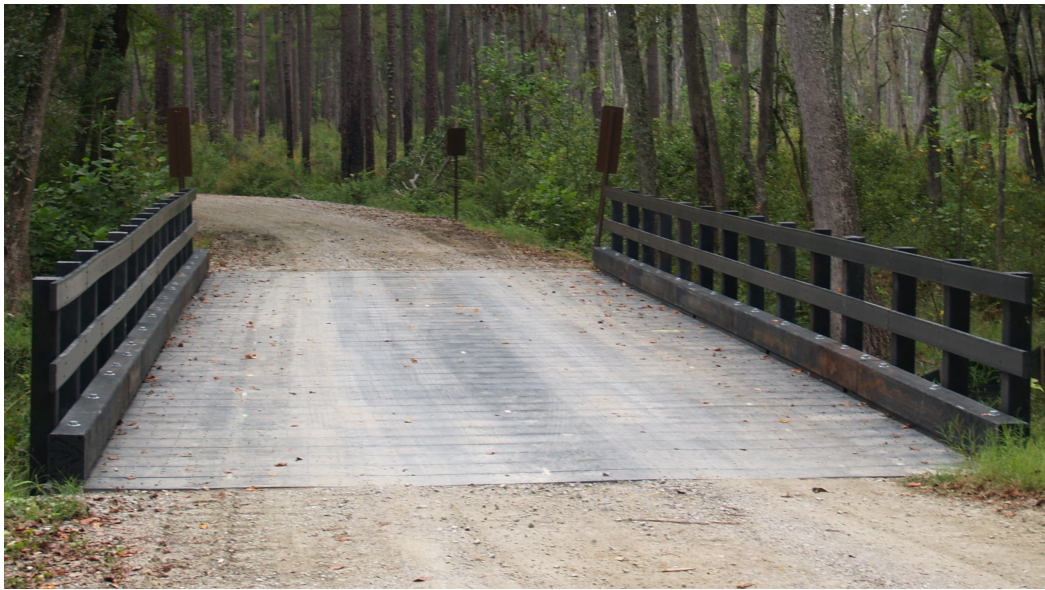
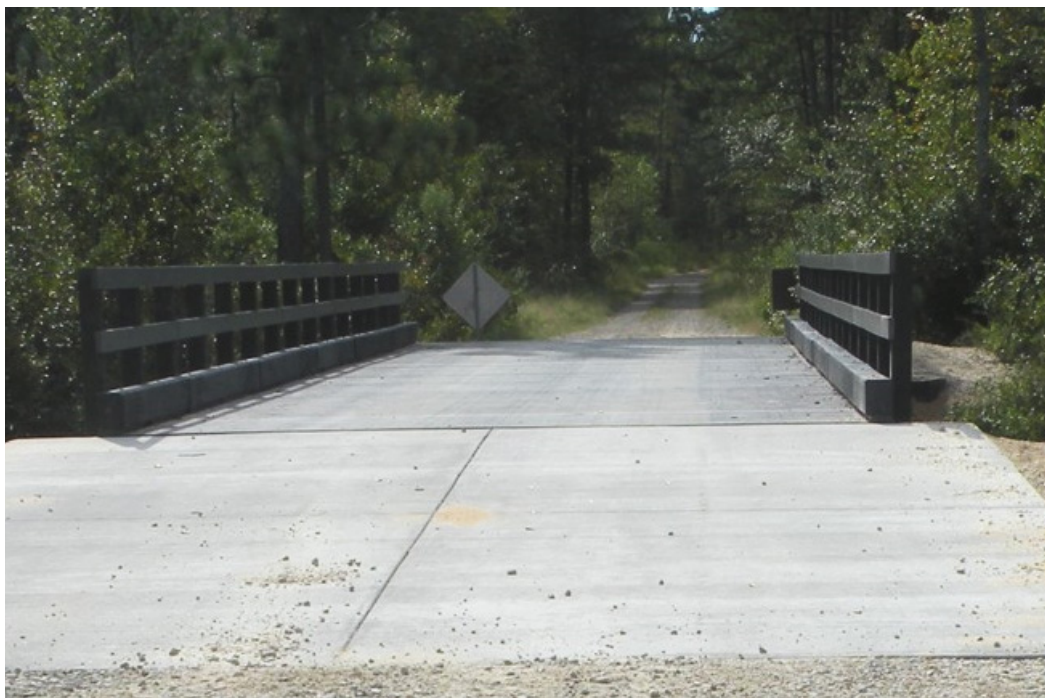
Figure 12. Three thermoplastic bridges constructed at Camp Mackall are: Bridge T-8518 (top); T-8519 (middle) and T-8520 (bottom). Foreground of bottom photo shows concrete approach added to Bridge T-8520 to accommodate a higher traffic volume than on Bridges T-8518 and T-8519.

The bridge design incorporated heavy-duty I-beam members up to 18 in. (46 cm) high and 18 in. (46 cm) wide (Figure 11 and Appendix A, Figure A7). The piles were made from the same glass fiber-reinforced thermoplastic composite material as the I-beams and decking. Stainless steel and other corrosion-resistant bolts and screw fasteners were used in the bridge construction. Measured end to end, Bridge T-8518 was approximately 38 ft (11.6 m) long, Bridge T-8519 was approximately 46 ft (14 m) long, and Bridge T-8520 was approximately 56 ft (17 m) long. The three bridges are shown in Figure 12.

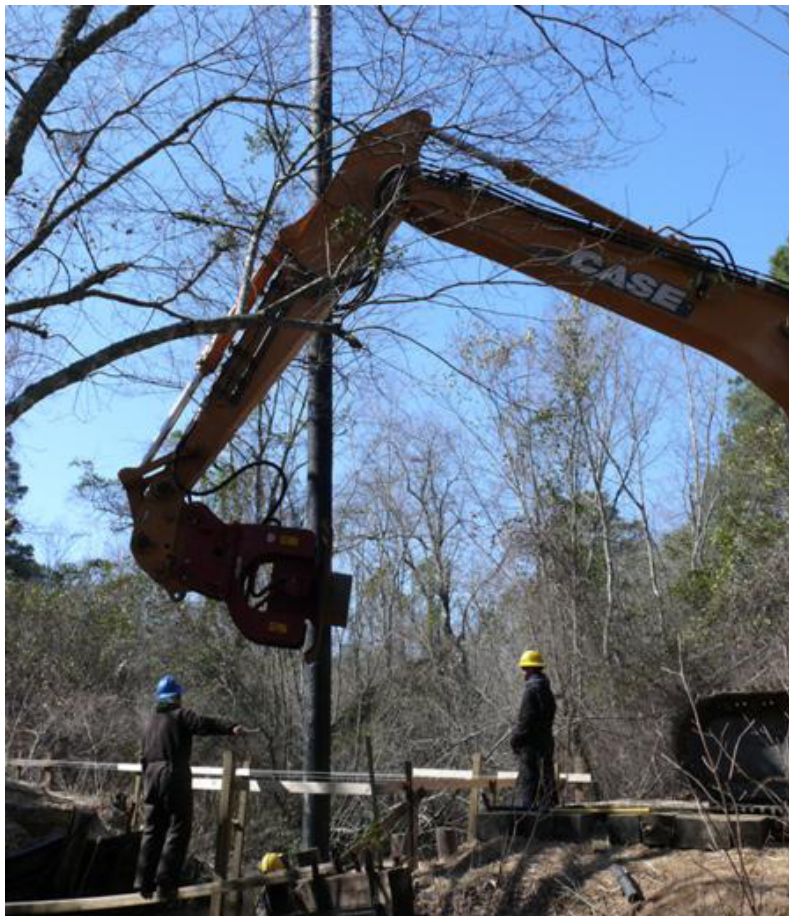
Figure 13. Piling being dropped in place by a crane and readied for driving with vibratory hammer.

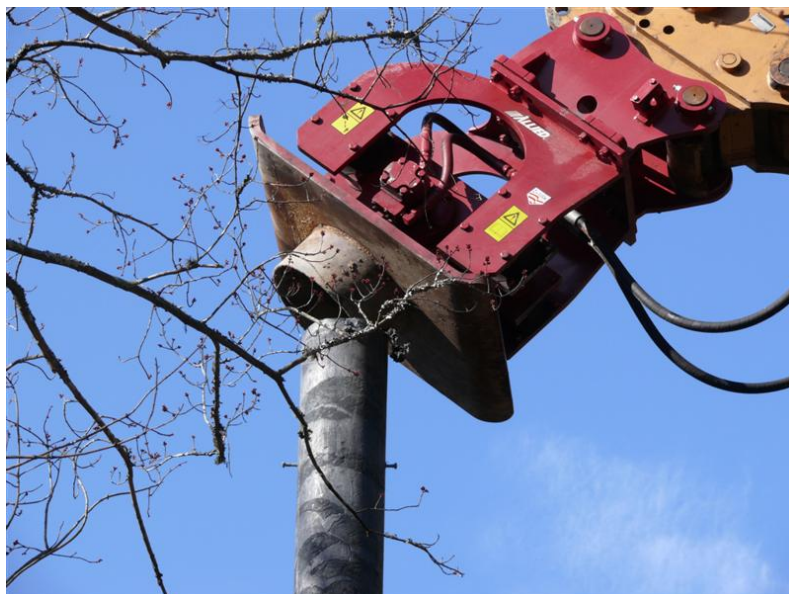
Figure 14. Vibratory hammer in place and driving pile.

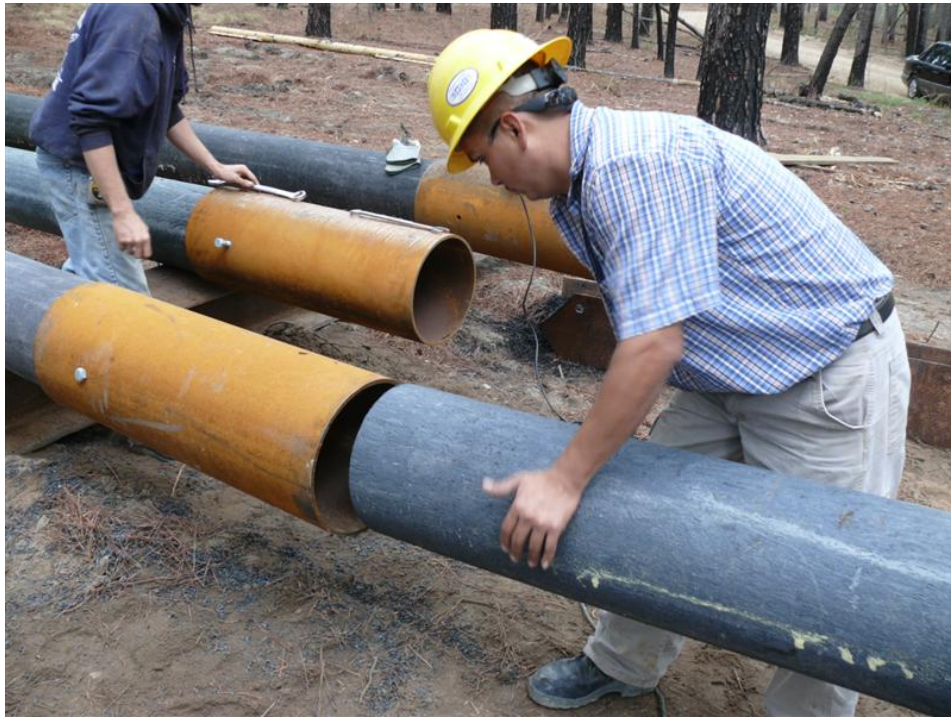
Figure 15. Splicing piles to achieve the depths needed for 37.5 ton (34 Mg) refusal at Bridge T-8519.

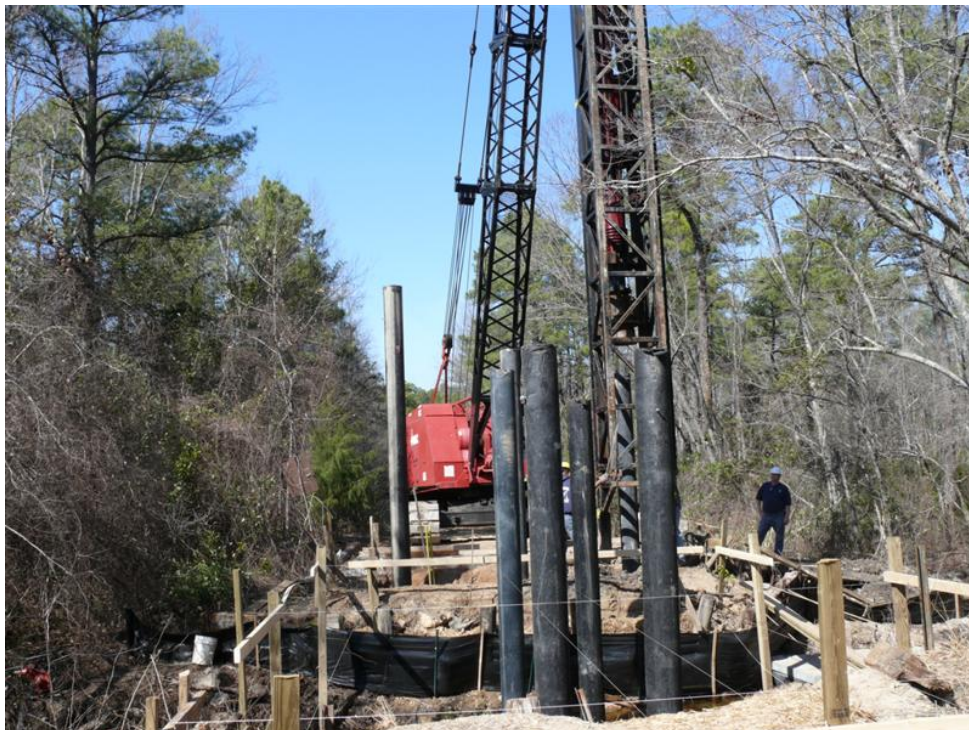
Figure 16. The 4 ton hammer in place and driving piling to 37.5-ton (34 Mg) limit.

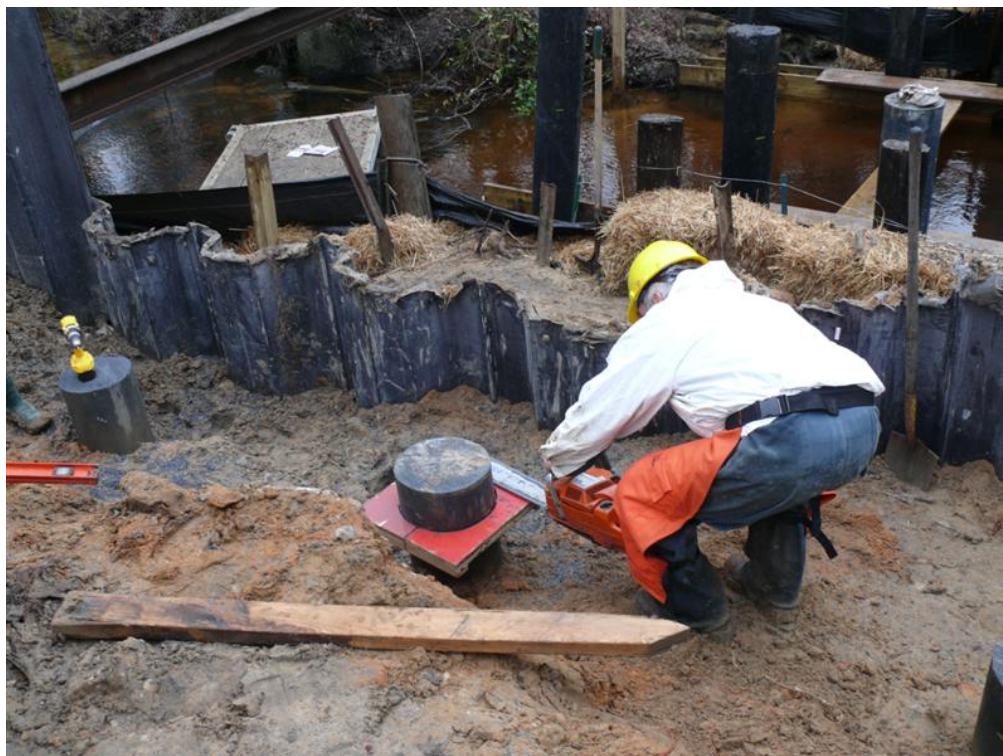
Figure 17. Trimming piling to be level.

The sequence for piling installation was as follows: pilings were measured level and cut; pilings were pinned to I-beams acting as the pile caps with 28 in. (71 cm) long, 1 in. (2.54 cm) diameter, smooth stainless steel rods; pilings were driven into an interference fit; and pilings were capped by a stainless washer that was tungsten inert gas (TIG)-welded on (**Error! Not a valid bookmark self-reference.**–Figure 20).

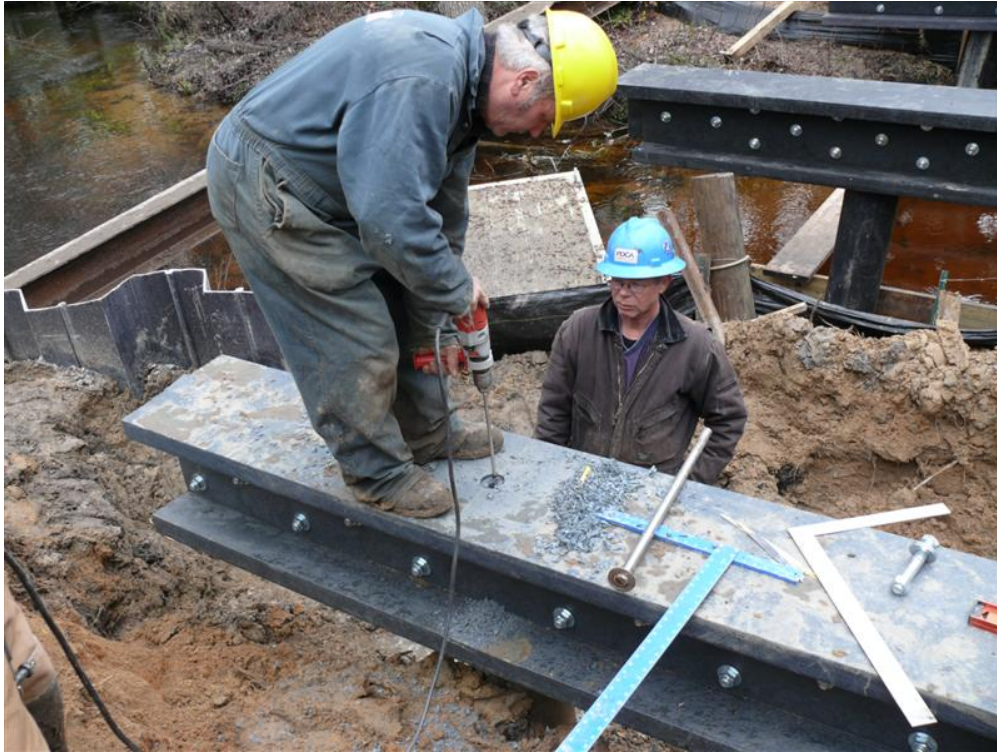
Figure 18. Drilling hole through pile cap in preparation for pin insertion.

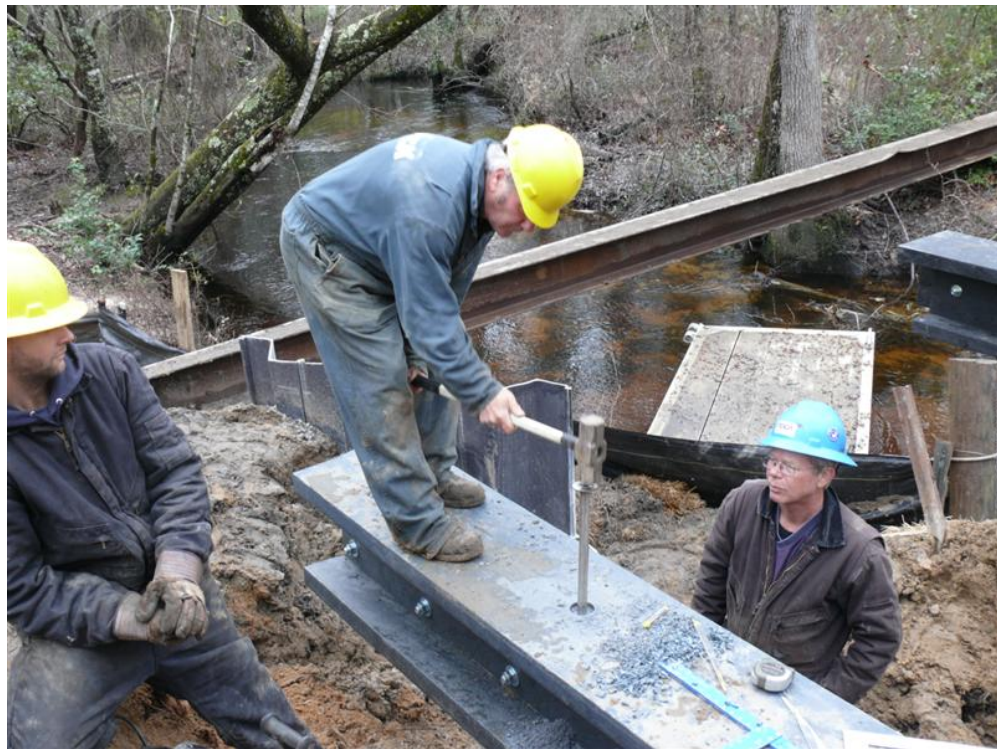
Figure 19. Hammering pin home through pile cap and into pile.

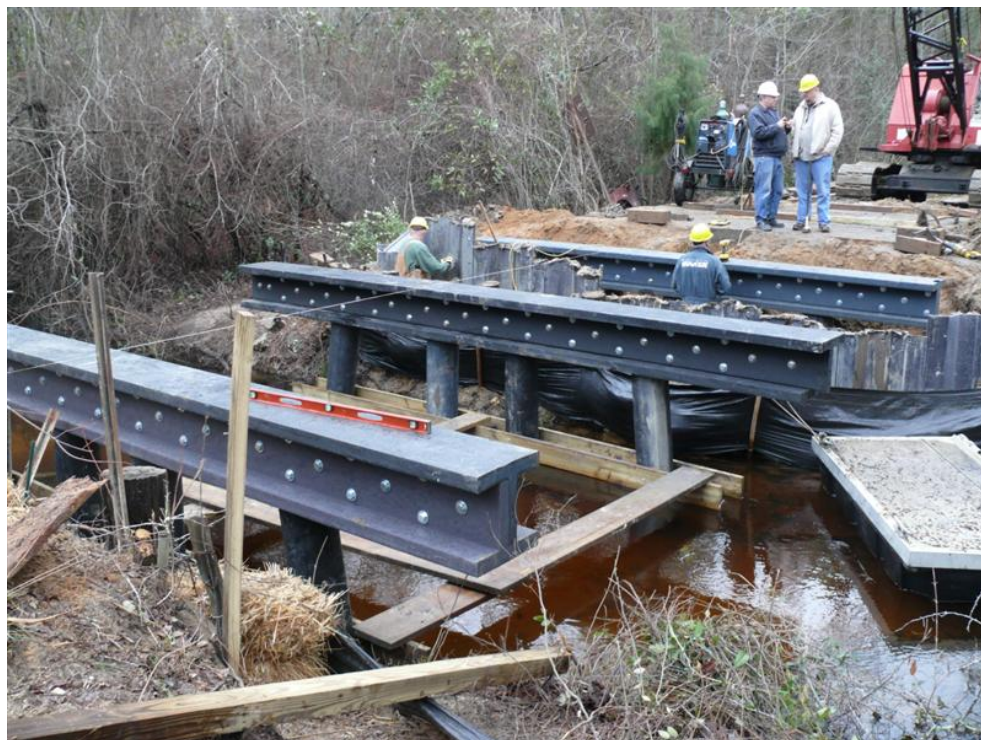
Figure 20. Pile caps in place and pinned.

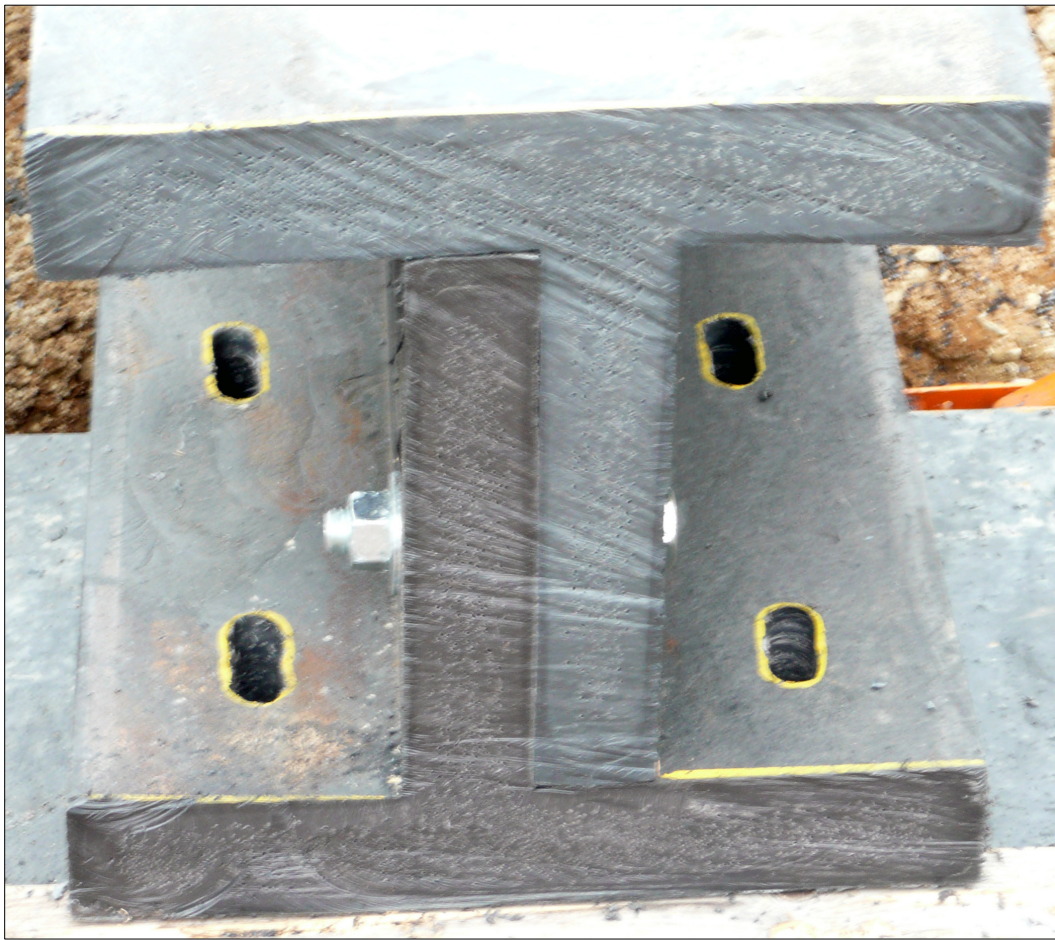
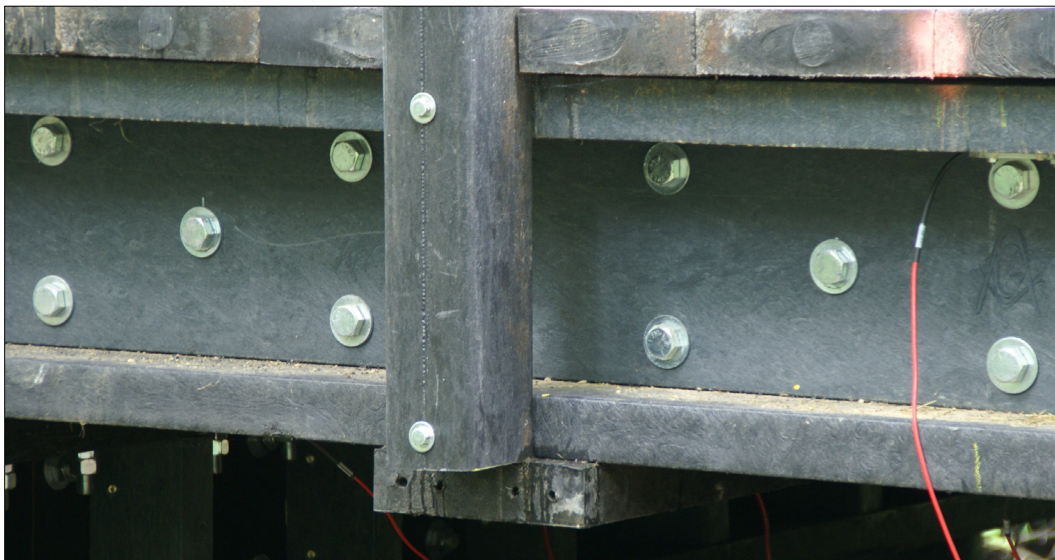
Figure 21. Top photo is close-up showing I-beam made from two T-beams; bottom photo shows bolt pattern on the beam web.

Each I-beam was factory-assembled from two T-beams that were held together with 1 in. (2.54 cm) diameter through bolts and glued. The pattern for bolting was staggered between one bolt in the center and then two spaced near the top and bottom of the flange, repeating every 18 in. (46 cm). Details of the fabrication of these large I-beams are given in Appendix A of this report (see Design Drawings, Detail 1, Figure A7; and Detail 3, Figure A8). Close-up photos of the actual products are shown in Figure 21.

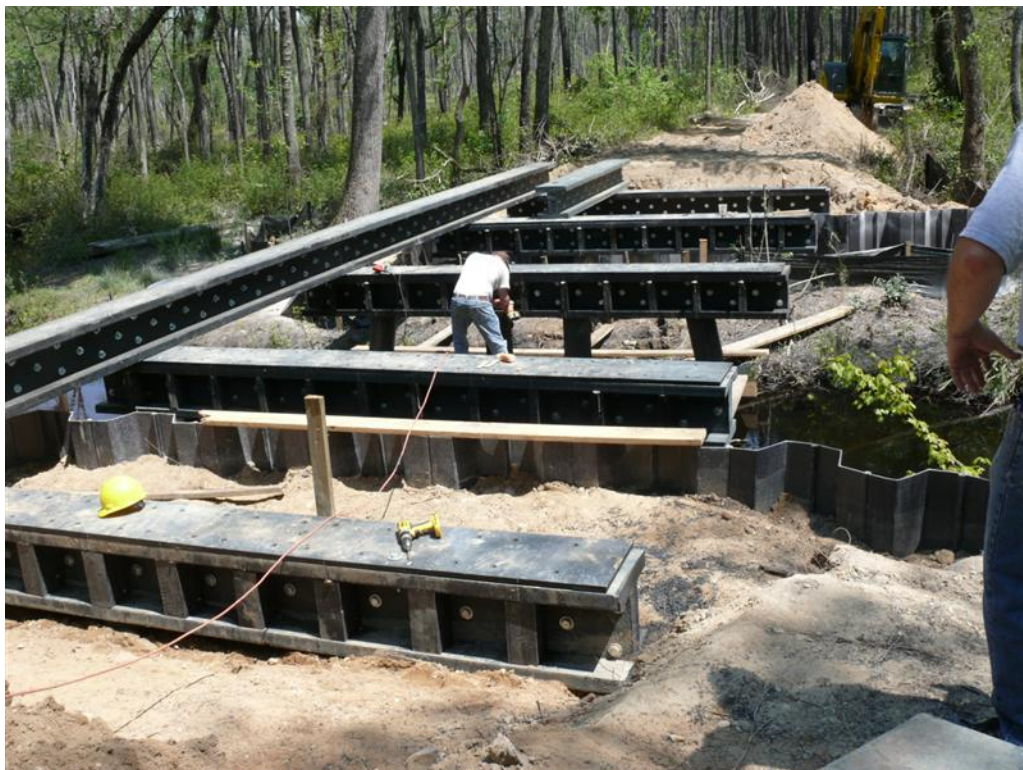
Figure 22. Installing stiffeners in pile caps, using screws and glue.  
Note 1-in. (2.54 cm) steel plate atop each pile cap.

There were 3 x 12 in. (7.6 x 30.5 cm) stiffeners affixed to the inside of the pile caps at 18 in. (46 cm) intervals, using screws and glue. The pile caps had 1 in. (2.54 cm) thick steel plates attached that were to be placed between the pile cap and the girders. These plates had holes precision-drilled in them to act as a template for construction. In addition to serving as a template, the sill plate serves to distribute stress over larger sections of the pile cap. Each plate was carefully placed on each pile cap by using laser sighting. Girders were affixed to the pile caps with four 1 in. bolts per joint, and the ends featured 4 in. (10 cm) slots that were 1 in. (2.54 cm) wide, to allow for thermal expansion. See Figure 22–Figure 26.

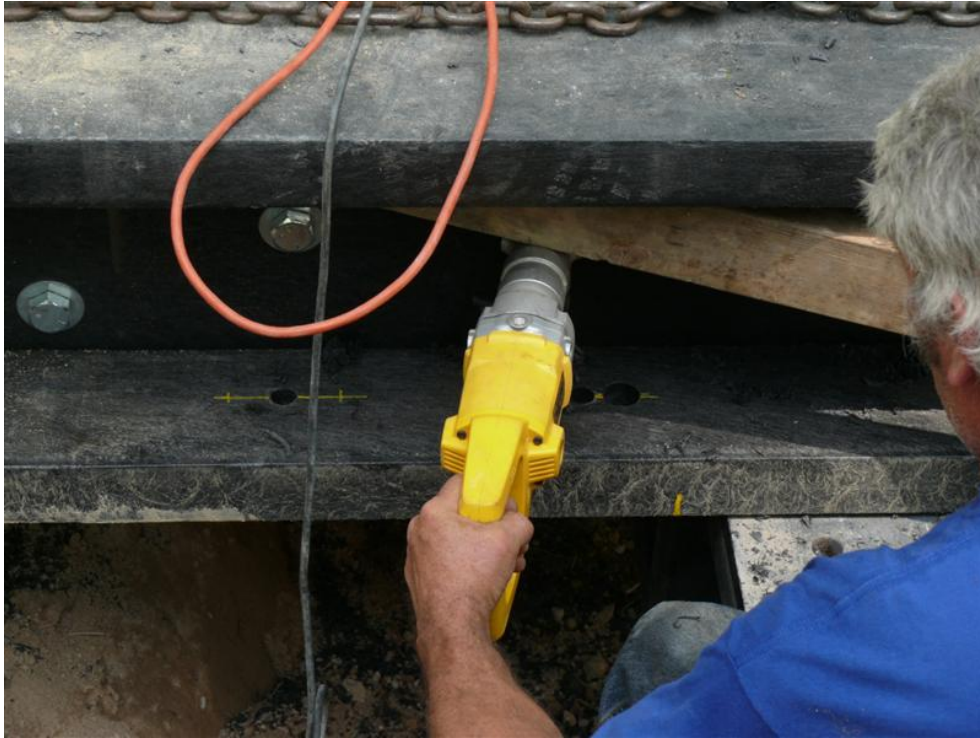
Figure 23. Drilling three holes in a line in preparation to cut thermal expansion slots.

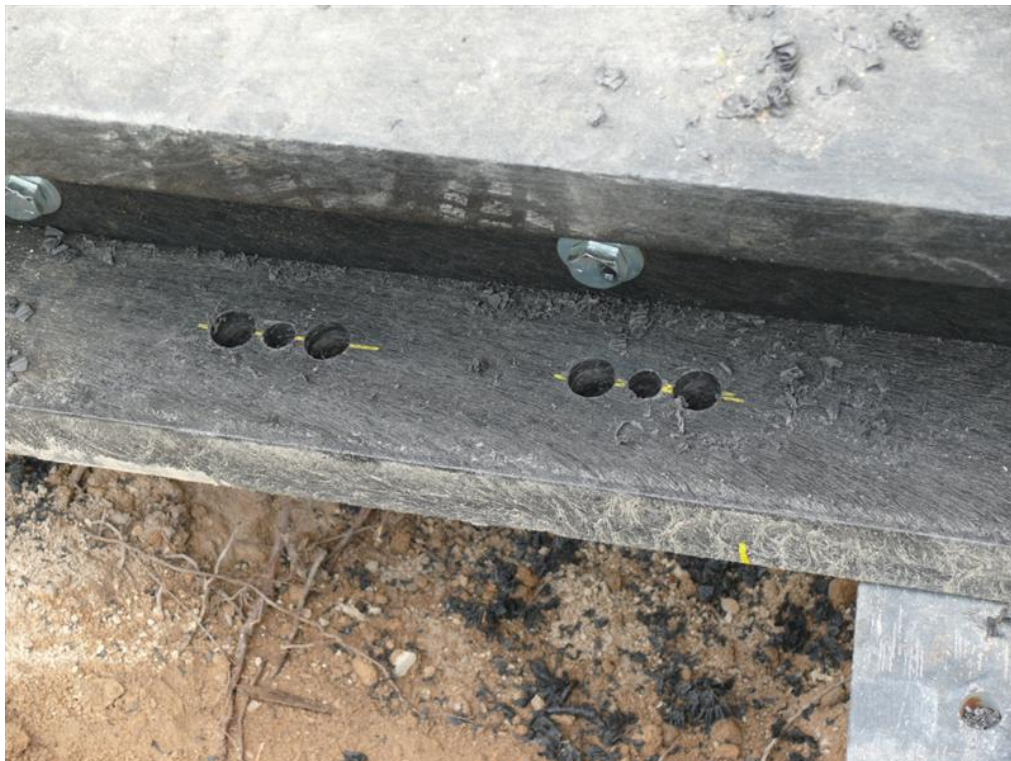
Figure 24. Three holes drilled to connect with a saw and create the thermal expansion slots.

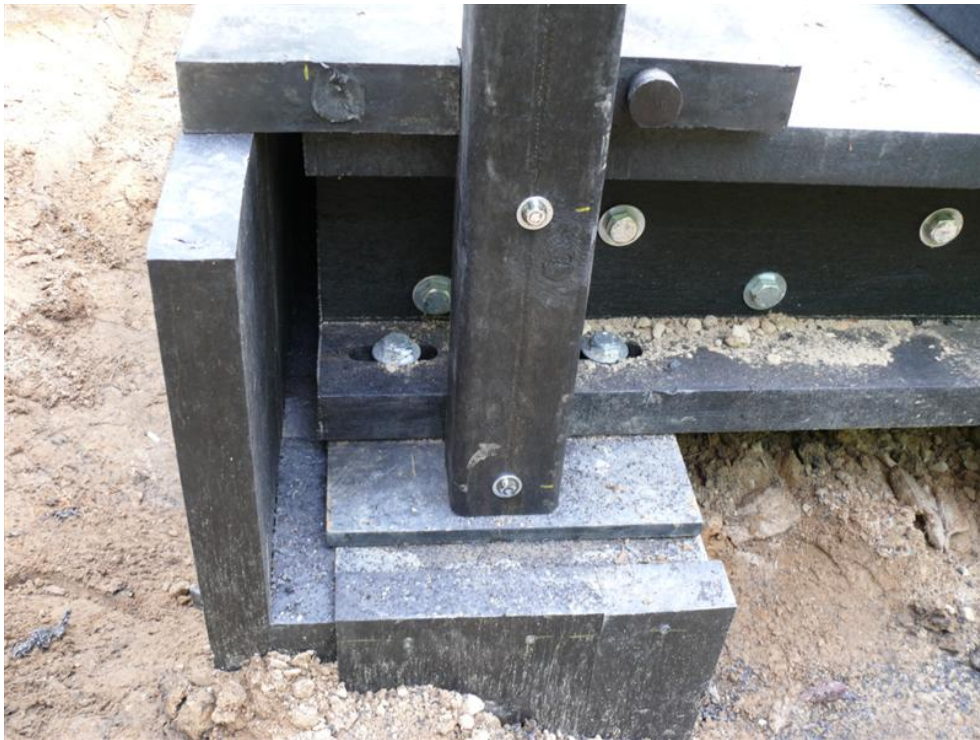
Figure 25. Bridge abutment, showing thermal expansion slots in girders.

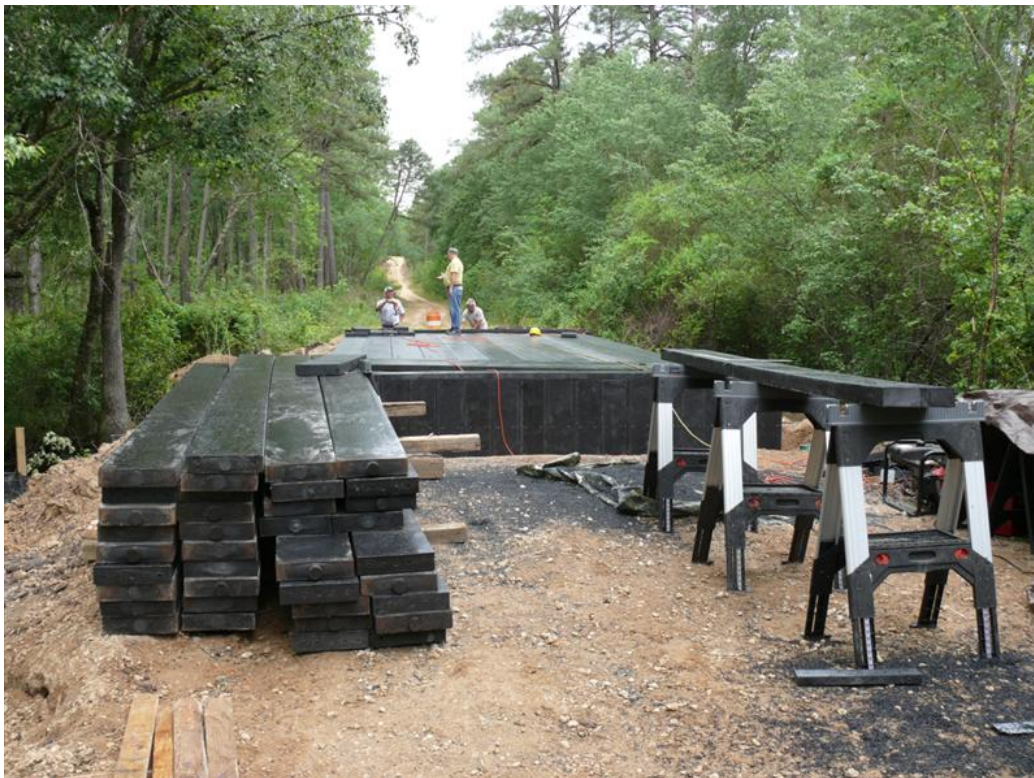
Figure 26. Decking and the abutments with the girders installed.

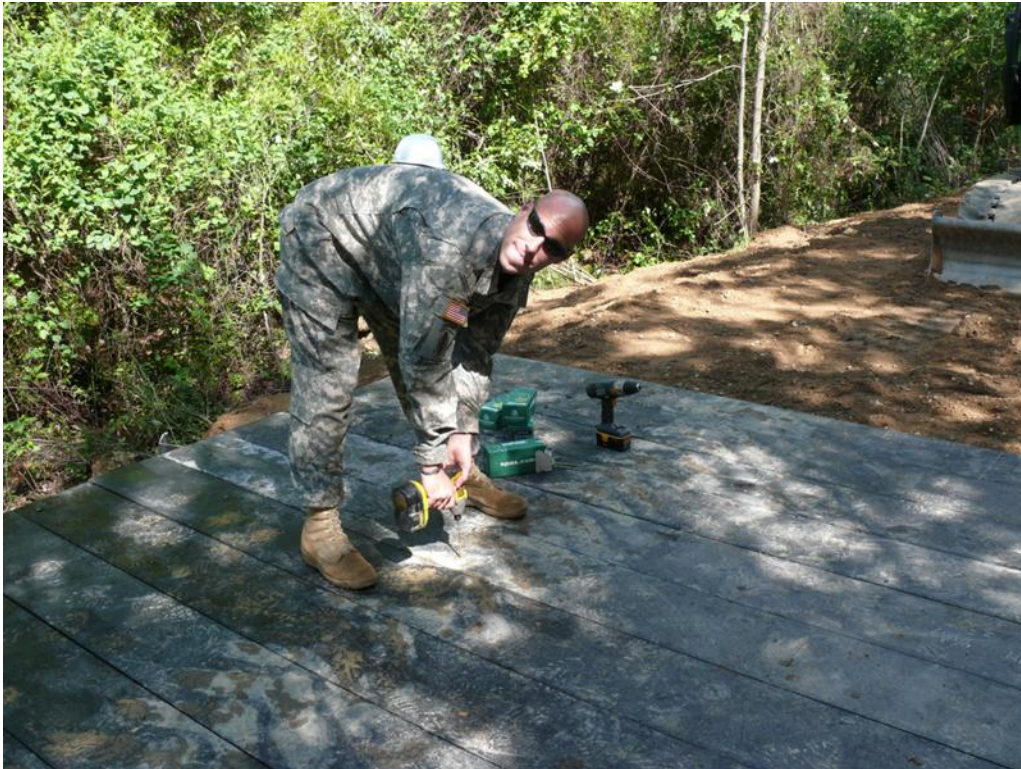
Figure 27. SGT Schrull, Camp Mackall Facility Management, installing deck screws.

Decking consisted of 3 x 12 in. (7.6 x 30.5 cm) boards that were slightly longer than the 16 ft 6 in. (5 m) width of the bridge. These boards were held in place by 4 M5 zinc-plated steel deck screws per joint initially, with more screws added later (in the form of a modification to Bridge T-8519) to account for the uplift forces when a steam roller crosses the bridge structure and is putting the load on one board at a time (Figure 27).

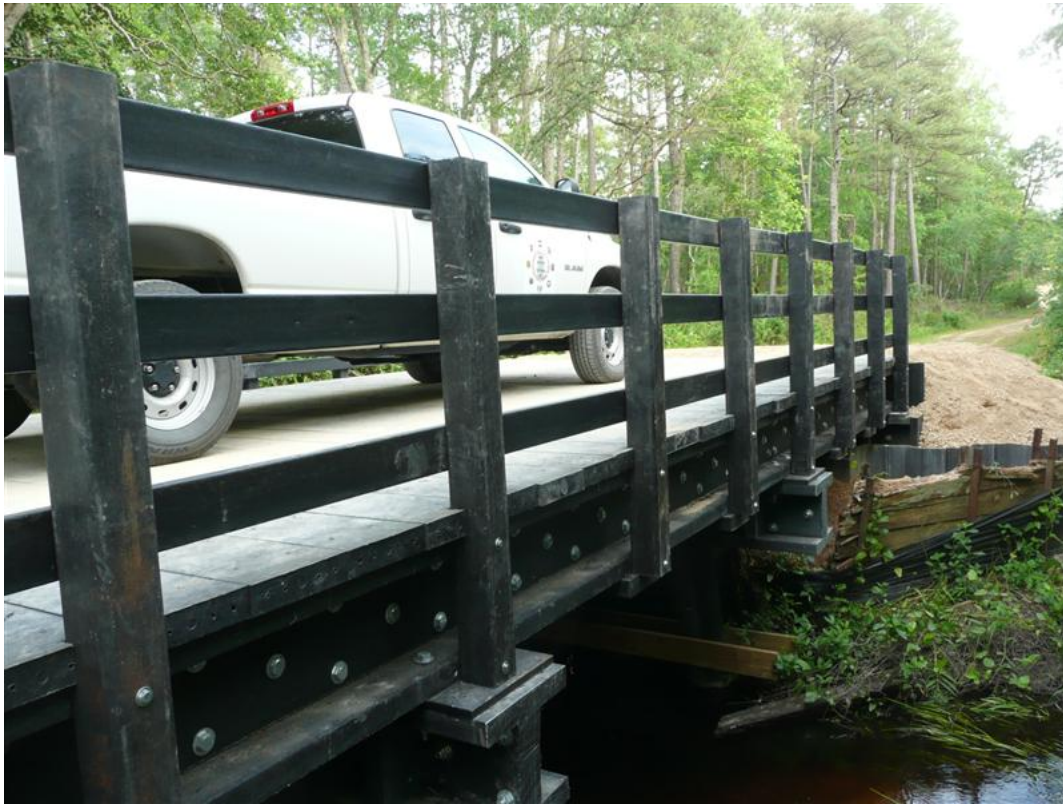
Figure 28. Side of deck, showing profile of bridge with railing details.

Railings were affixed to the edge of the bridges and bolted with lag bolts. Later, as part of the same modification mentioned above, rub railings were added in the form of railroad ties bolted to the edge girders with long side installed vertically (Figure 28).

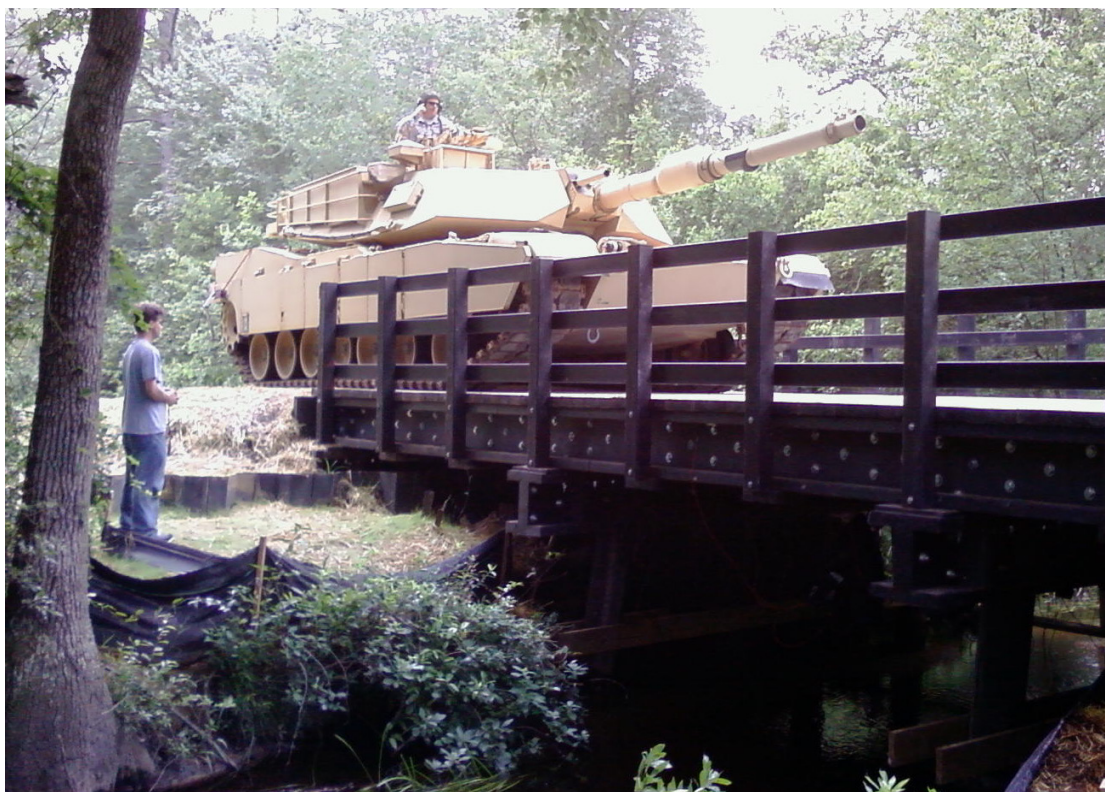
**Figure 29. M-1 tank crossing the thermoplastic composite bridge (T-8518) during initial load testing.**

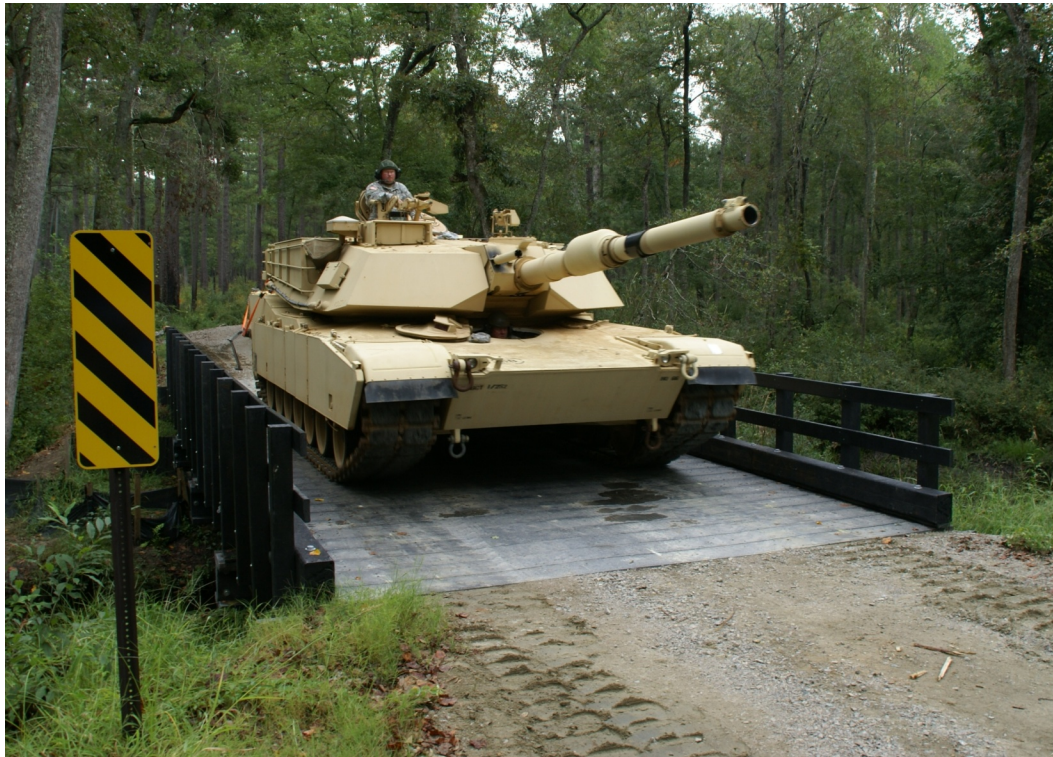
Figure 30. M-1 tank crossing Bridge T-8519.
